# FLAMMABILITY TEST REPORT

TEST REPORT #1325.2R, Rev IR

## **HOT-STOP® 'L'** LITHIUM ION FIRE CONTAINMENT KIT **STORAGE BAG**

Prepared for  
**INDUSTRIAL ENERGY PRODUCTS, INC.**  
56 Newcomer Rd, Mount Joy, PA 17552

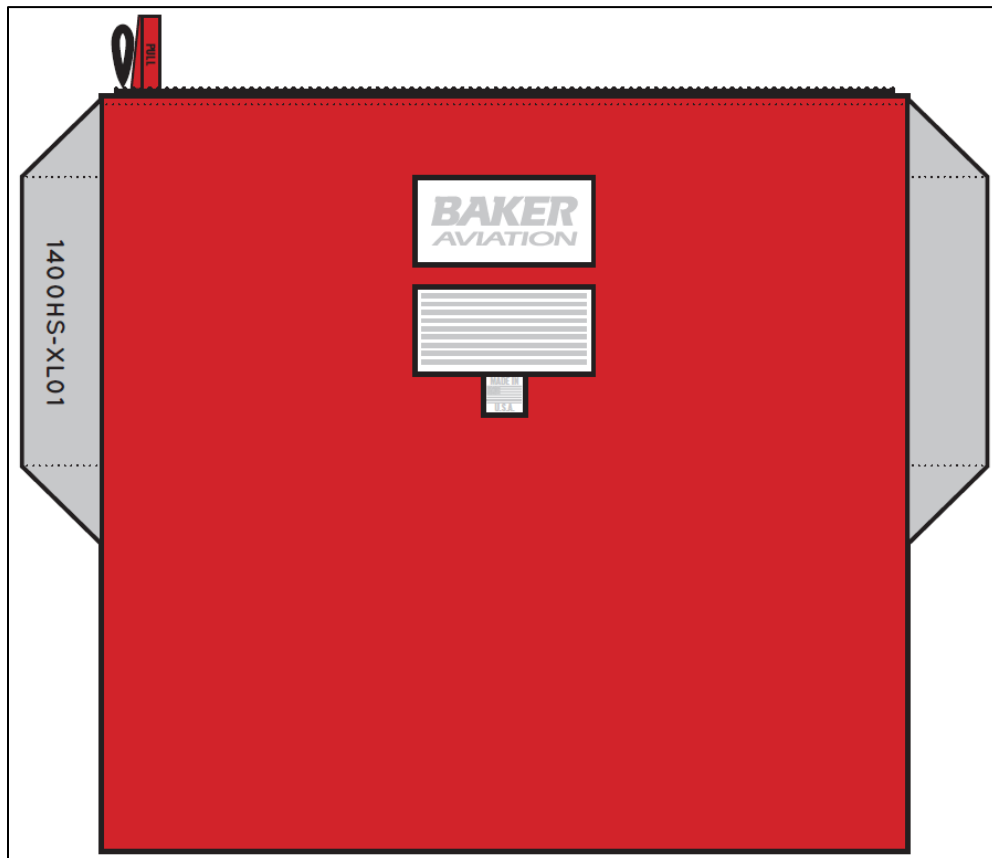
The HOT-STOP® 'L' Fire Containment Kit is a well-known solution which has safely contained fires, explosions and toxic smoke emissions from Lithium Ion powered devices without the aid of a water supply. HOT-STOP® is a registered trademark of Industrial Energy Products, Inc.

Figure 1 - Example of Containment Kit

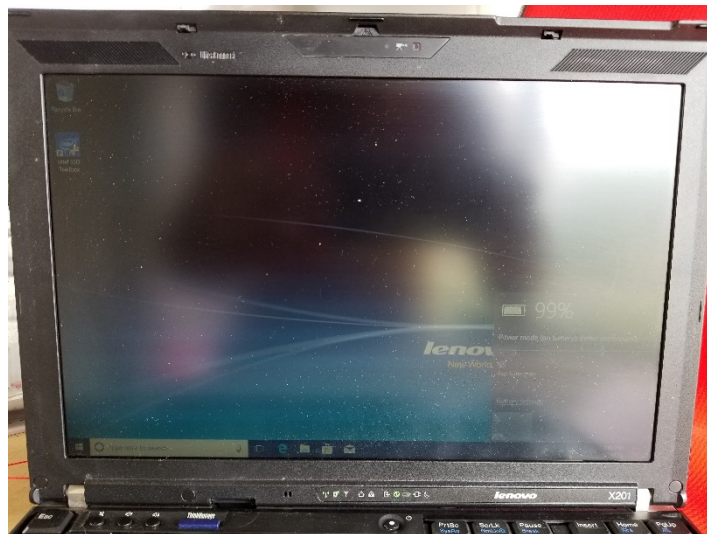
The device used for testing was a 12.1" laptop with a Li-Ion 94 Wh battery. The battery was comprised of 9 cylindrical cells. The device was charged to 100% battery prior to testing.

Figure 2. Tablet Device for Testing

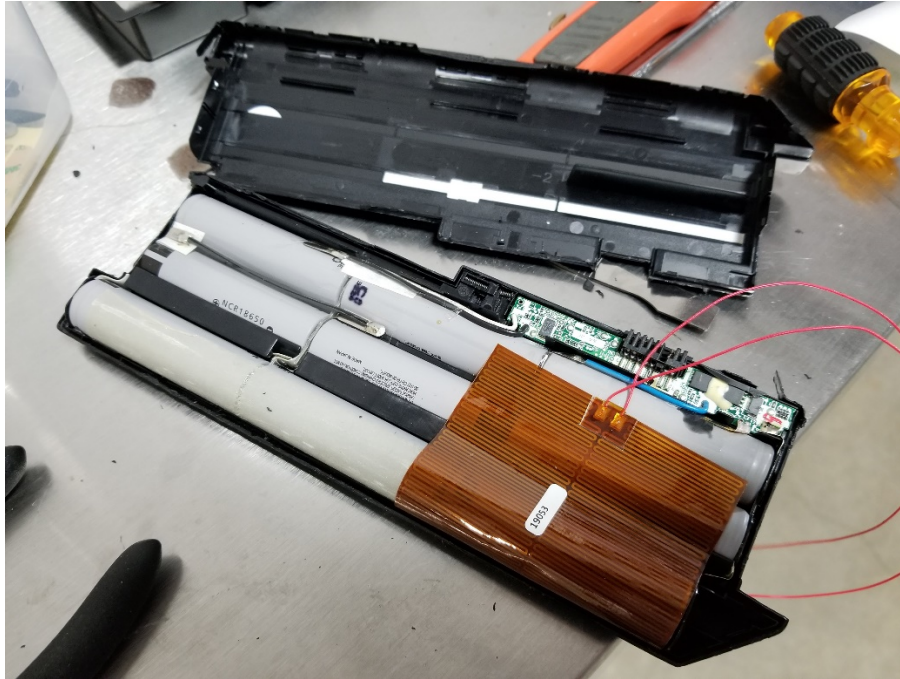
The battery casing was opened to reveal the various cells. A film heater was placed on top of two cells and the casing was sealed.

Figure 3. Film Heater on Cells

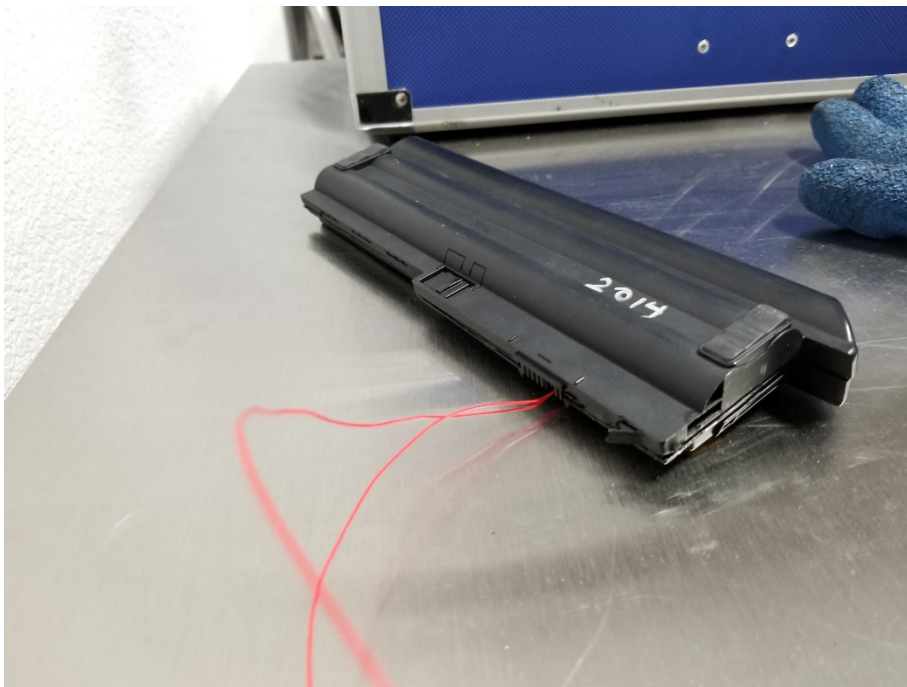
Figure 4. Battery Closed Up

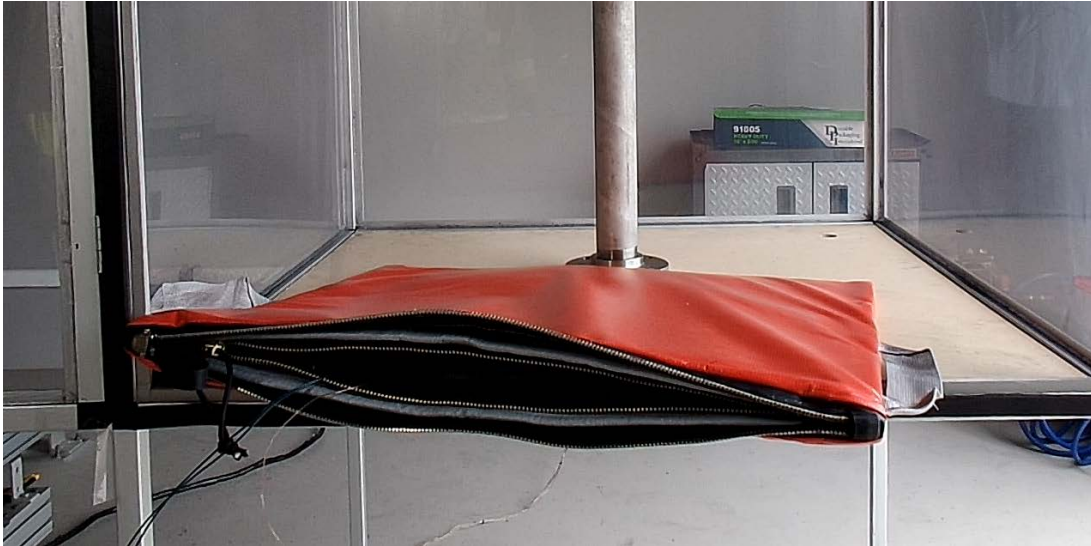
The battery was placed back into the laptop and the laptop was inserted into the containment kit. A voltage was applied to the heater to increase the temperature of the battery cells.

Figure 5. Laptop Inside Containment Kit

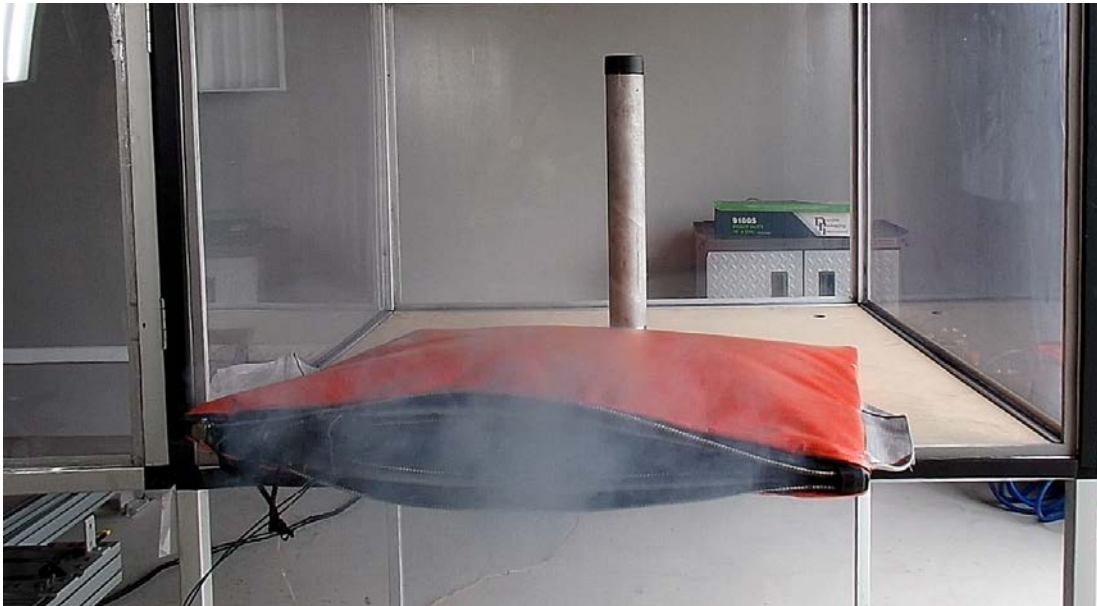
The temperature of the battery continued to increase for about four minutes until thermal runaway was initiated.

Figure 6, Initial Battery Ignition

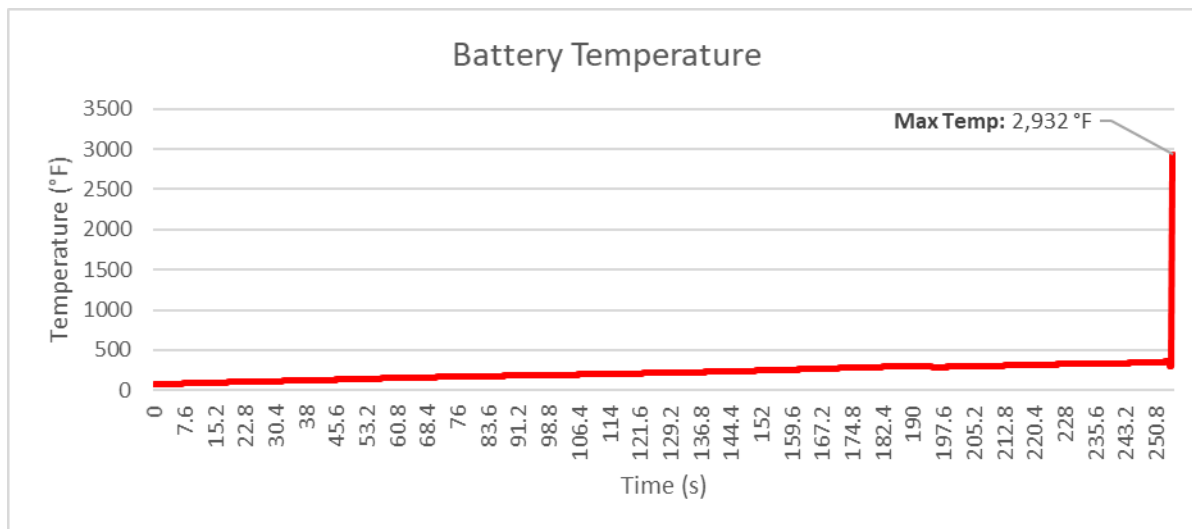
The battery reached approximately 300 °F before igniting. Immediately after ignition, the recorded peak temperature was 2,932 °F. At this point, the wires to the battery were cut and the bag was sealed.

Figure 7. Graph of Battery Temperature

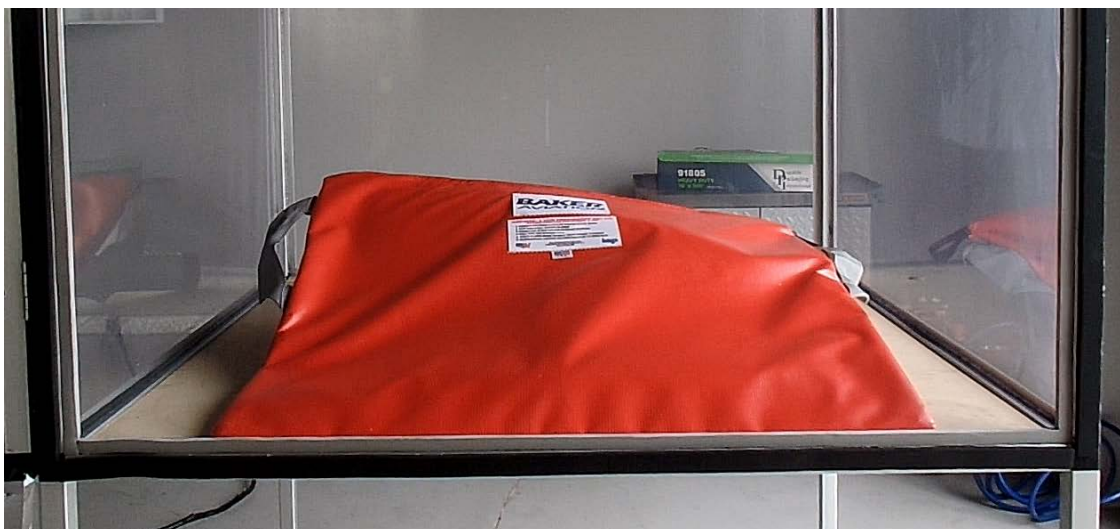
The containment kit consists of three levels of closures: an inner hook & loop seal, an inner zipper, and an outer zipper seal. Once the outer zipper was closed, the kit was left alone for observation for approximately 20 minutes. During that time, no further propagation of thermal runaway occurred, and no smoke was observed exiting the bag.

Figure 8. Kit Under Observation

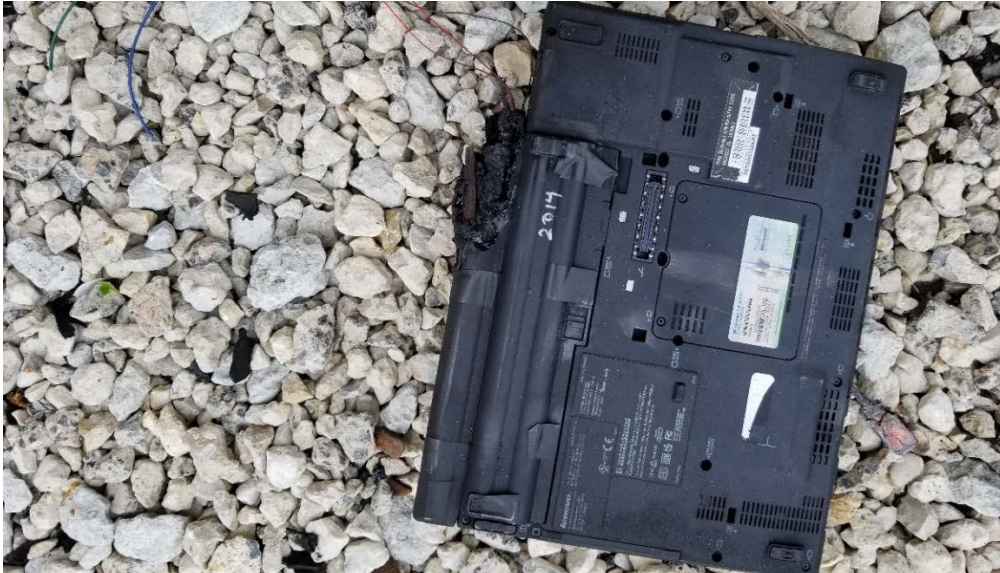
When the bag was opened, it was determined that only one cell had experienced thermal runaway and no propagation to adjacent cells had occurred.

Figure 9. Battery Post-test

Previous testing on Lithium Ion batteries resulted in propagation of the thermal runaway to adjacent cells. In both tests performed inside the storage bag, the thermal runaway was limited to the single cell triggered and no propagation occurred, suggesting that the HOT-STOP® 'L' Fire Containment Kit is suppressing the resulting fire and preventing propagation to adjacent cells.

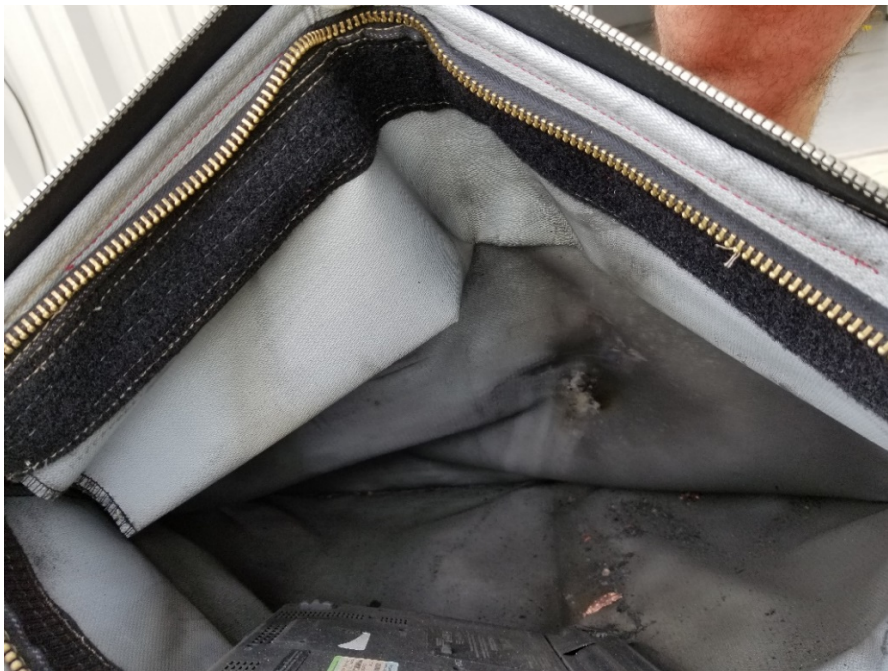
The bag was inspected, and only minor evidence of damage was found. The Storage Bag is comprised of an additional sub-liner material after the primary inner liner for added protection. The sub-liner had experienced minor damage. No damage was found to the primary inner liner.

Figure 10. Containment Kit Post-test

No evidence of smoke was seen coming out of the kit after it was sealed in either test. Only minor damage to the inner-most liner of the bag was found after the first round of testing, and no additional damage after the second round of testing. The damage did not extend to the primary inner liner nor to the exterior of the bag.

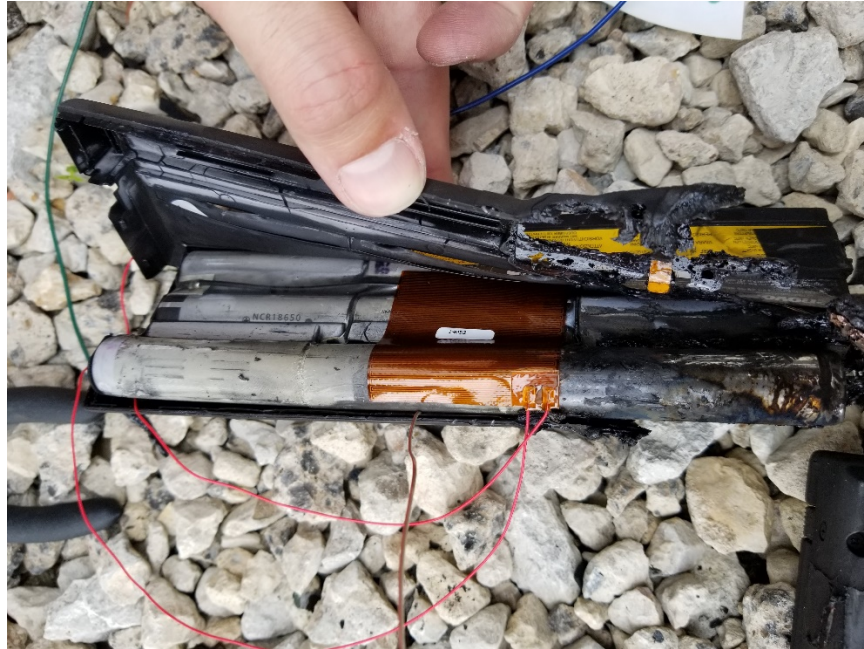
Since the kit was found to be in good condition, a second test was then run on the same laptop and bag. The battery casing was re-opened to reveal the remaining eight cells. A film heater was placed on top of two cells and the casing was sealed. The battery was placed back into the laptop.

Figure 11. Film Heater on Cells

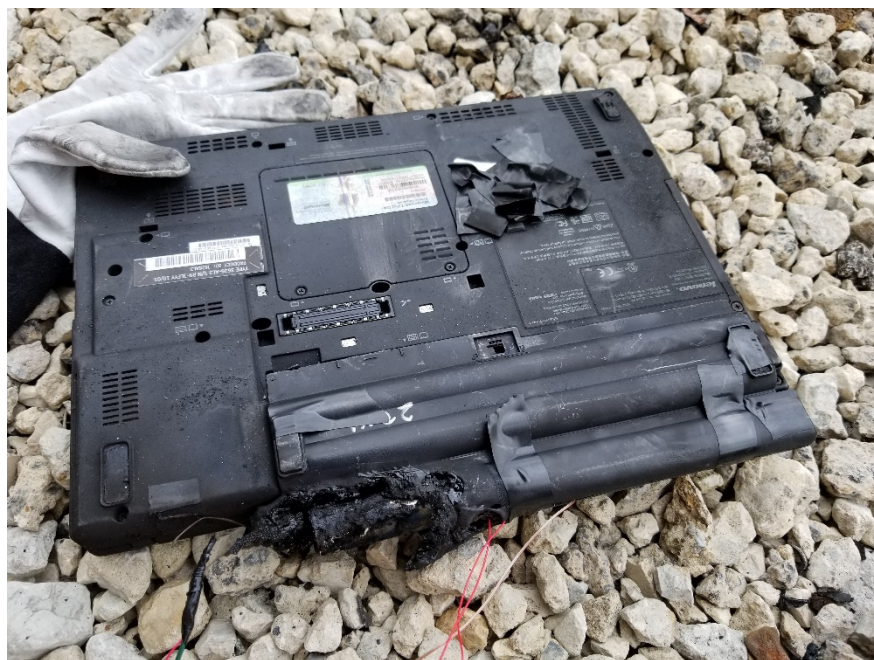
Figure 12. Battery Closed Up

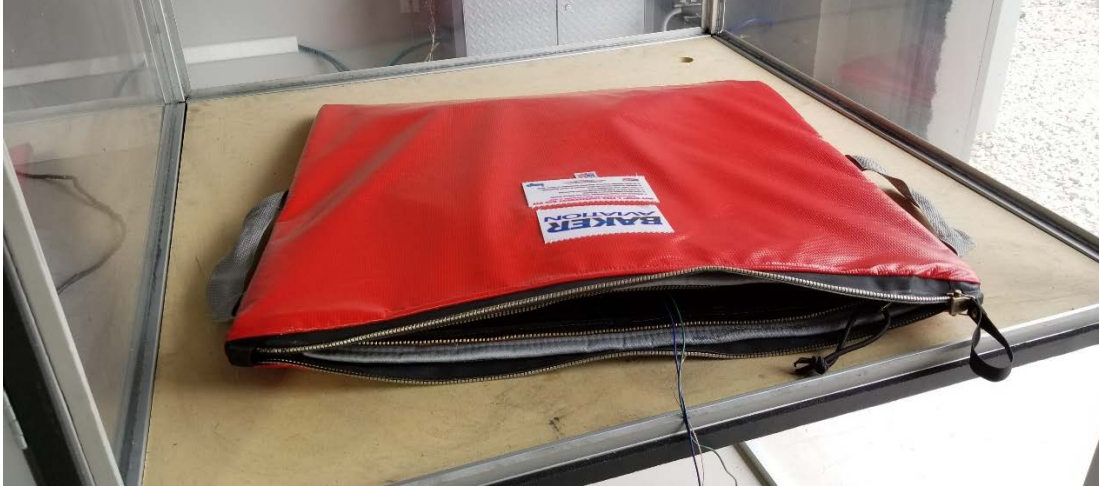
The laptop was inserted back into the containment kit. A voltage was applied to the heater to increase the temperature of the battery cells.

Figure 13. Laptop Inside Containment Kit

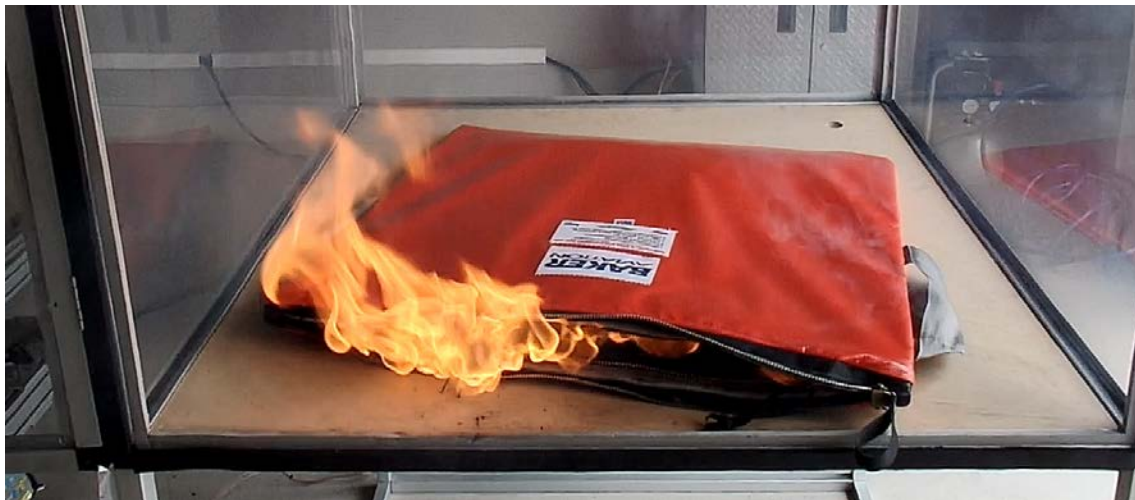
The temperature of the battery continued to increase for about eight minutes until thermal runaway was initiated.

Figure 14, Initial Battery Ignition

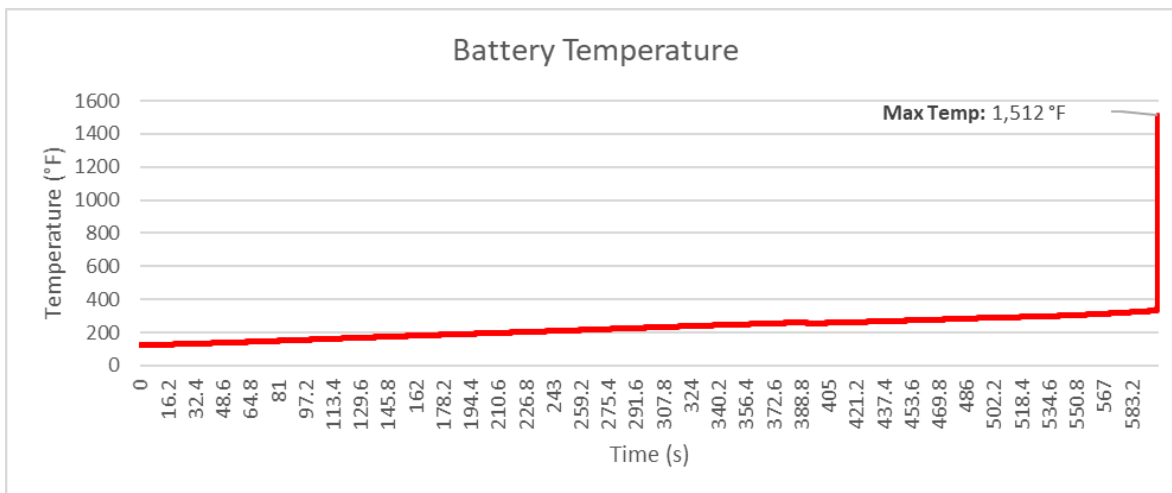
The battery reached approximately 330 °F before igniting. Immediately after ignition, the recorded peak temperature was 1,512 °F. At this point, the wires to the battery were cut and the bag was sealed.

Figure 15. Graph of Battery Temperature

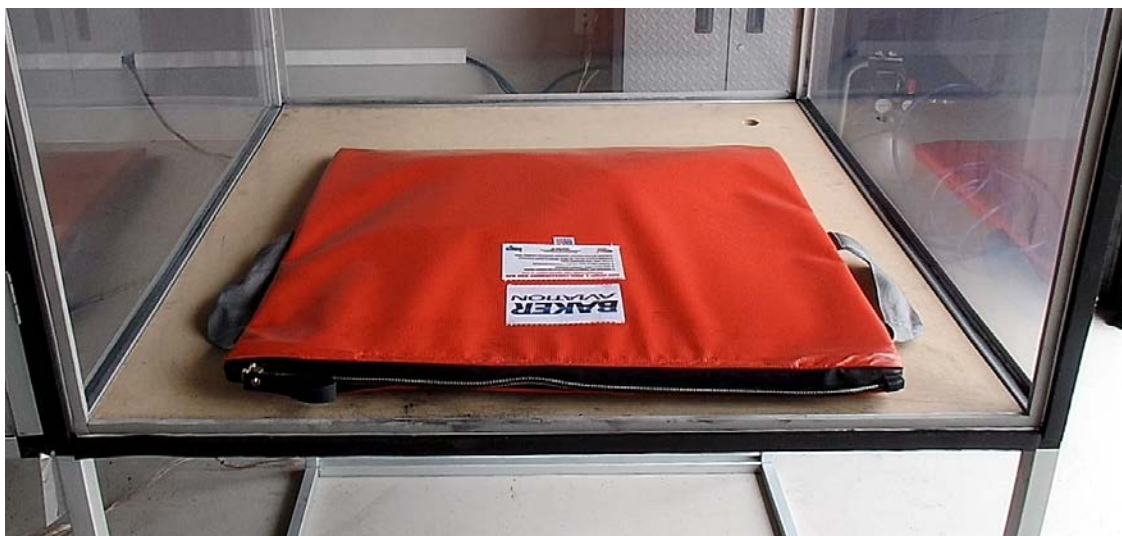
Once the outer zipper was closed, the kit was left alone for observation for approximately 20 minutes. During that time, no further propagation of thermal runaway occurred, and no smoke was observed exiting the bag.

Figure 16. Kit Under Observation

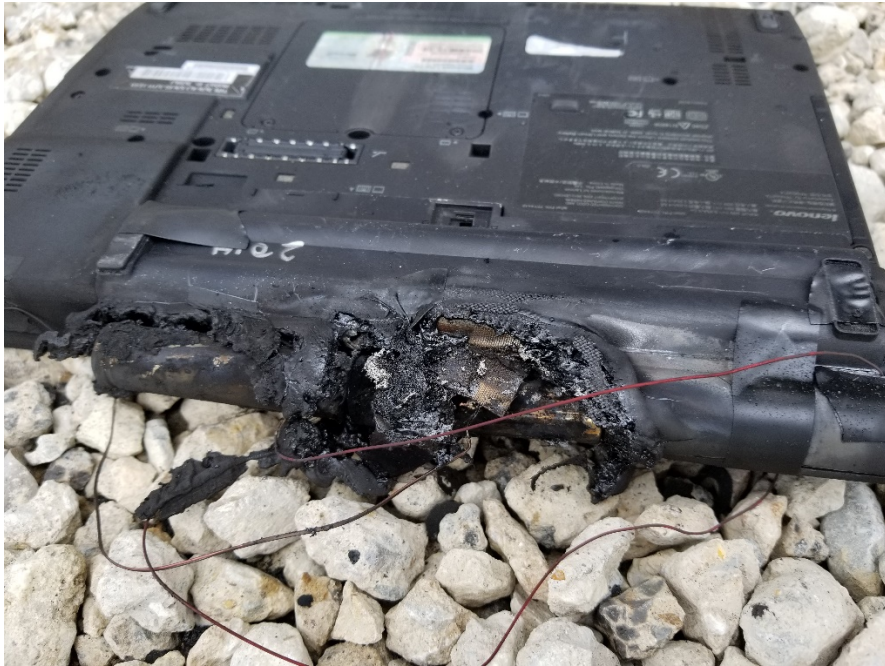
When the bag was opened, it was determined that again, only one cell had experienced thermal runaway and no propagation to adjacent cells had occurred. The bag was inspected, and no further evidence of damage was found.

Figure 17. Battery Post-test

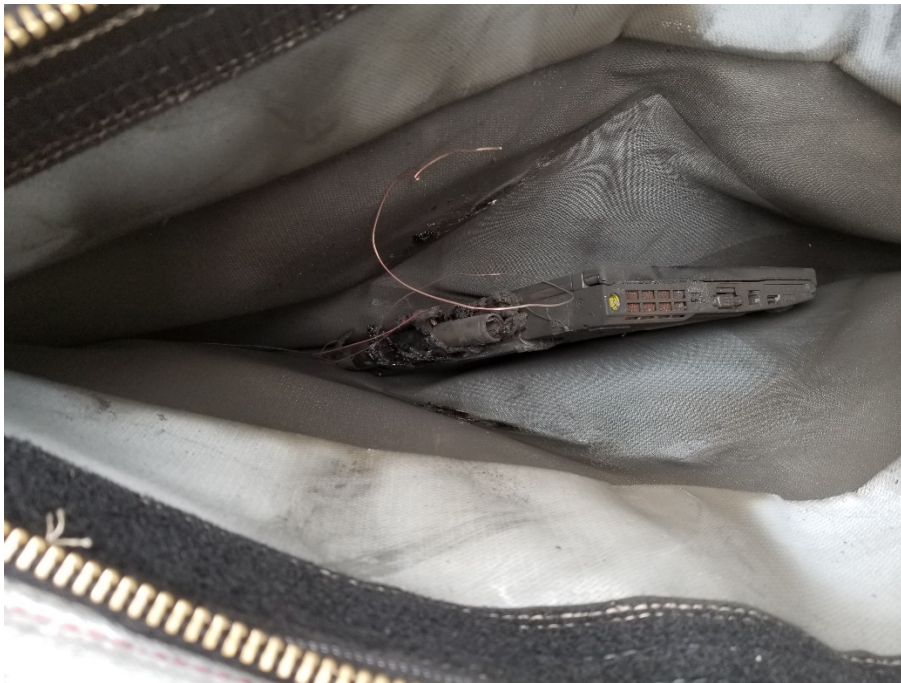
Figure 18. Containment Kit Post-test
